Magnetics™ Pickups

EMG pickups refurbishment

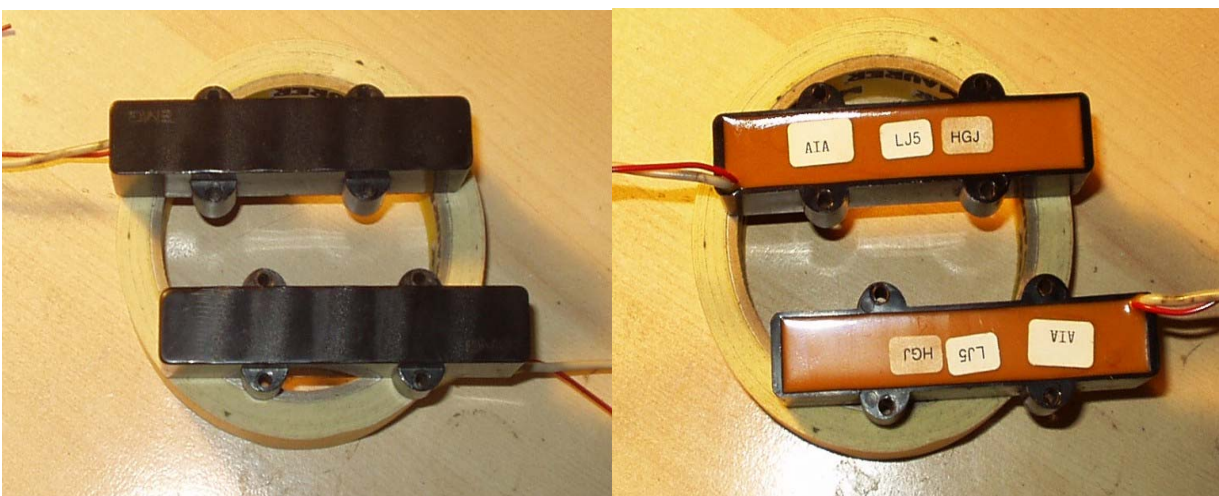
Alberto Bronner, customer, friend, and possessor of a beautiful 1988 Warwick Tumb, found the bridge pickup scratching with impoverishment overall sound with an increase of background noise, resulting by physiological consumption of the active components of Internal preamp. After 20 years of using defect may be unfortunately norm. A solution was required... Replace the pickups with a new EMG J5 set, or any other exact replacement. Alberto asked if it was possible to do something to get the new pickups inside EMG covers in order to maintain the original look intact ... Obviously yes!

Original

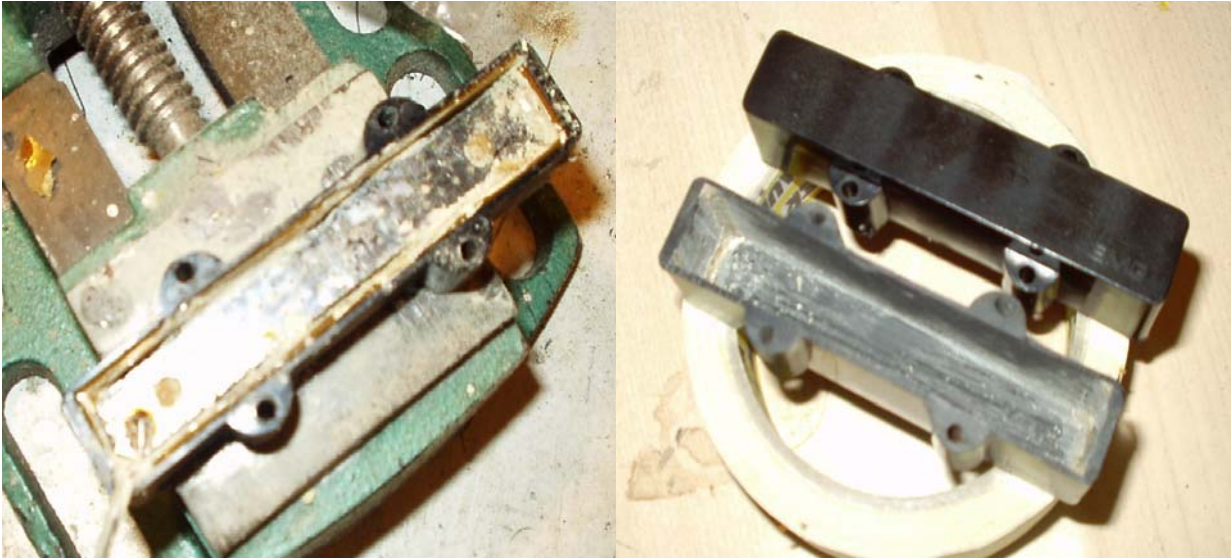
Epoxy resin milling and original covers cleaning

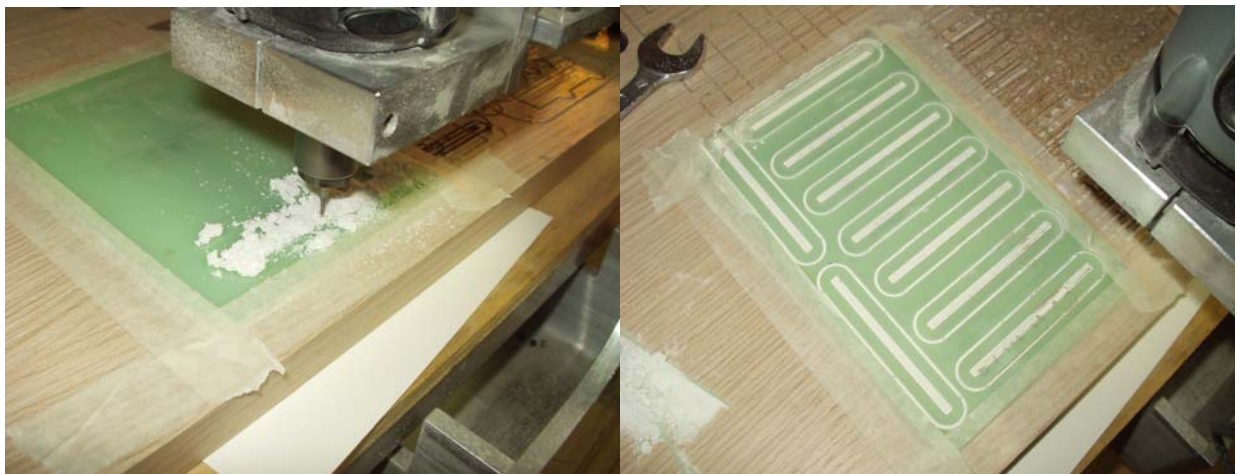
Cutting coils and assembly ...

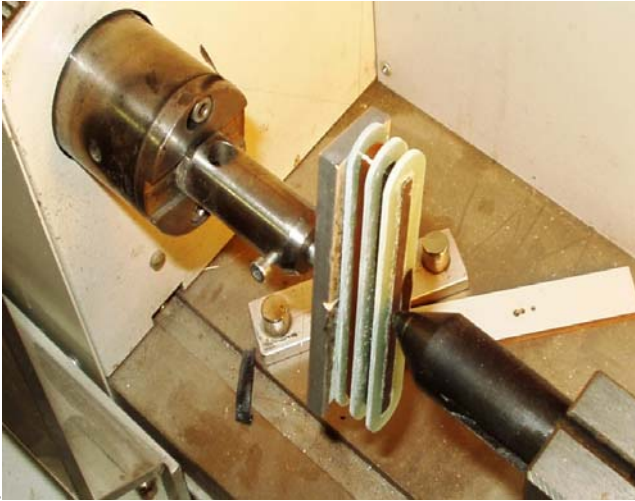
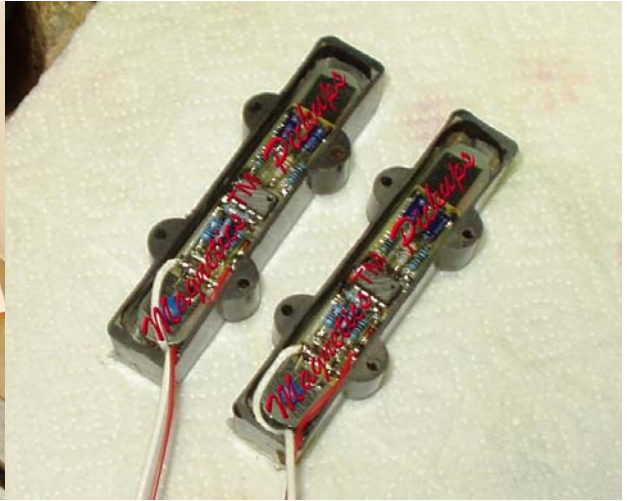
Winding and pickups assembly

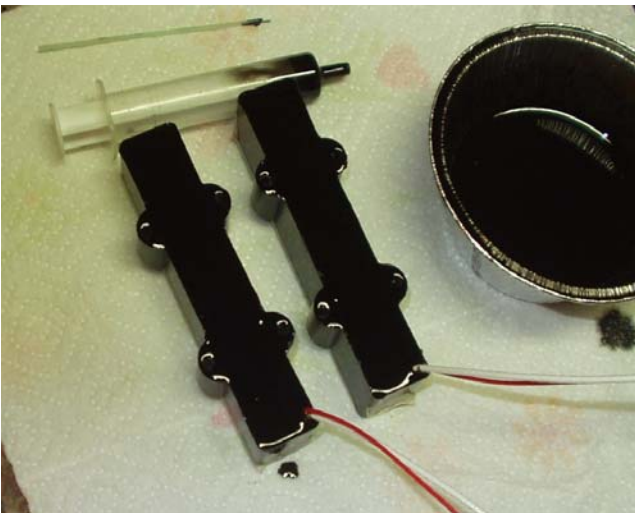
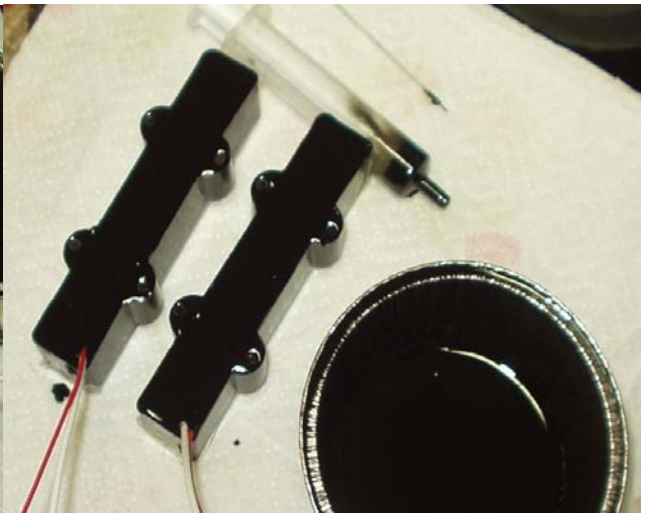
Epoxing...

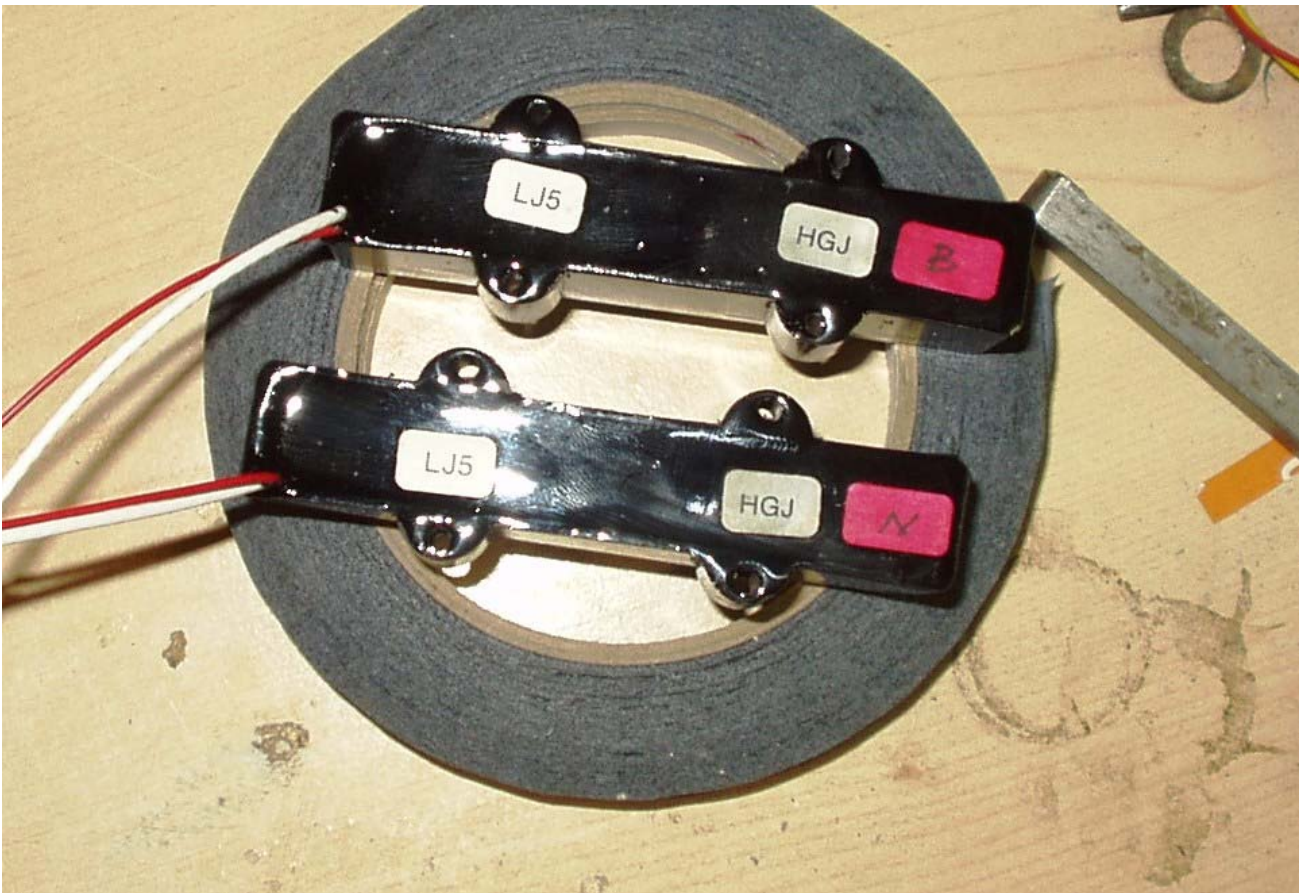
End of job Original labels applied.

Work was not easy, it takes a lot of experience and adequate equipment. The result was obviously appreciated by the customer, besides not find substantial differences in the original sound , he immediately noticed greater energy and quietness. What can I say ... A difficult work, but very funny.
